# SQUAW VALLEY PUBLIC SERVICE DISTRICT

## 2015 WATER AND SEWER SYSTEM REPORT

Prepared April 2016

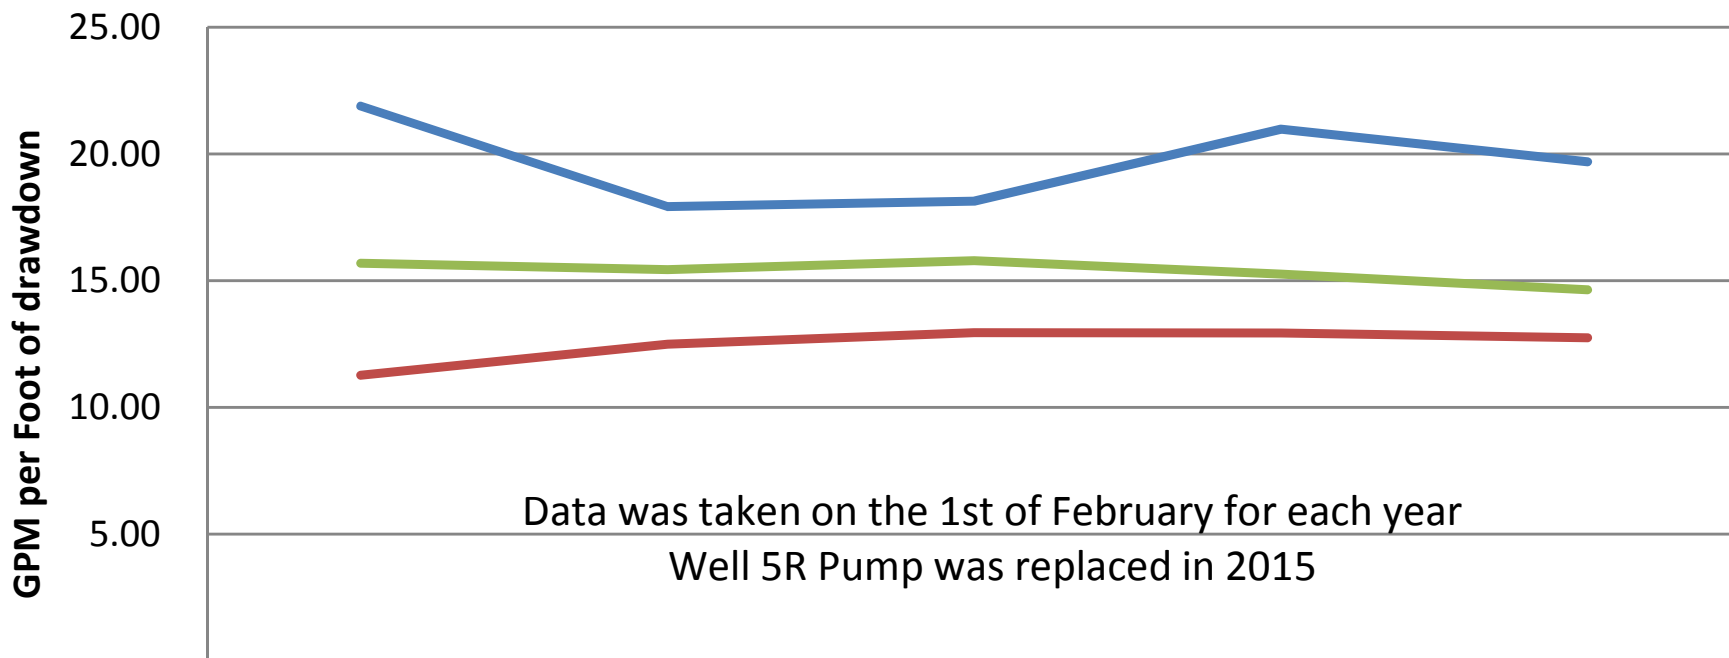
## SVPSD Production Wells Specific Capacity

2012	2013	2014	2015	2016
Well 1R	21.90	17.92	18.14	20.98	19.69
Well 2R	11.27	12.50	12.95	12.93	12.75
Well 5R	15.70	15.44	15.79	15.27	14.64
