OLYMPIC VALLEY PUBLIC SERVICE DISTRICT

2025 WATER & SEWER SYSTEM REPORT

Prepared April 2026

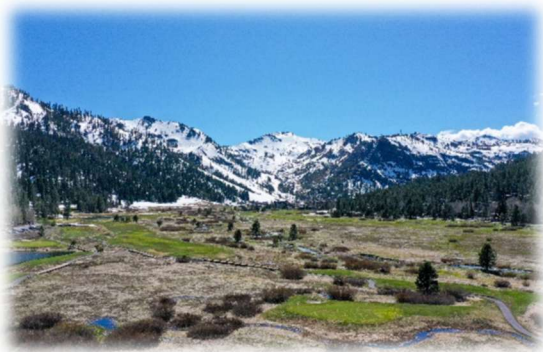
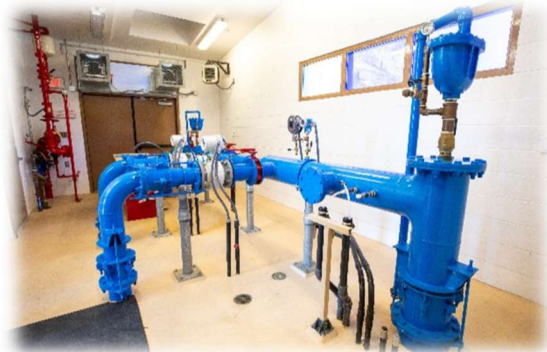
- 2025 Maximum Level: 6189.9' (May 12, 2025)
- 2025 Minimum Level: 6182.1' (September 29, 2025)
- 2025 Static Water Level Change: 7.8'
- 2024 Static Water Level Change: 9.4'

- 2025 Water Year Total: 52.34"
- 60-Year average: 53.55"
- Percent of Average: 97.74%

- ** *Lowest recorded aquifer level: 6,174.0 feet (October 12, 2001).*
- *** *Creek bed elevation near Well 2r: 6,186.9 feet. (West Yost Associates)*
- **** *Precipitation total measured from October 2024 - September 2025.*
- ***** *Historical precipitation data (1994-2004) may have inaccuracies*
- ***** *Water production totals may differ from SCADA due to time of day reading variations.*
